MARYLAND INVENTORY OF HISTORIC PROPERTIES HISTORIC BRIDGE INVENTORY MARYLAND STATE HIGHWAY ADMINISTRATION MARYLAND HISTORICAL TRUST

NAME AND SHA NO.: 8028

LOCATION LN L. MD 227 and Matteryomen Creek	
Road Name and Number: MD 227 over Mattawoman Creek City/Town: Mattawoman Natural Environmental Area X vicinity County: Charles	
Ownership: X State County Municipal Other	
Bridge projects over: _ Road _ Railway X Water _ Land	
Is bridge located within designated district?: _ yes X no NR listed district _ NR determined eligible district locally designated _ other Name of District _	
BRIDGE TYPE	
Timber Bridge Beam Bridge Truss-Covered Trestle Timber-and-Concrete	
Stone Arch Bridge	
Metal Truss Bridge	
Moveable Bridge Swing Bascule Single Leaf Bascule Multiple Leaf Vertical Lift Retractile Pontoon	
Metal Girder Rolled Girder Rolled Girder Concrete Encased Plate Girder Plate Girder Concrete Encased	
Metal Suspension	
Metal Arch	
Metal Cantilever	
X Concrete Concrete Arch Other Concrete Slab X Concrete Beam Rigid Frame Type Name 437

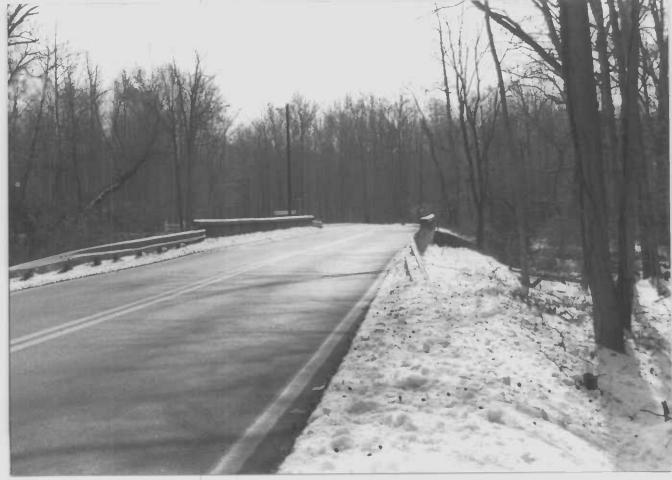
1/4

CH-383
CHARLES COUNTY, MD
TIM BATCHER
8 FEB 1995
MARYLAND SHPO SHA
BRIDGE NO. 8028 OVER MATTAWOMEN CREEK
VIEW LOOKING EAST ALONG RT. 227

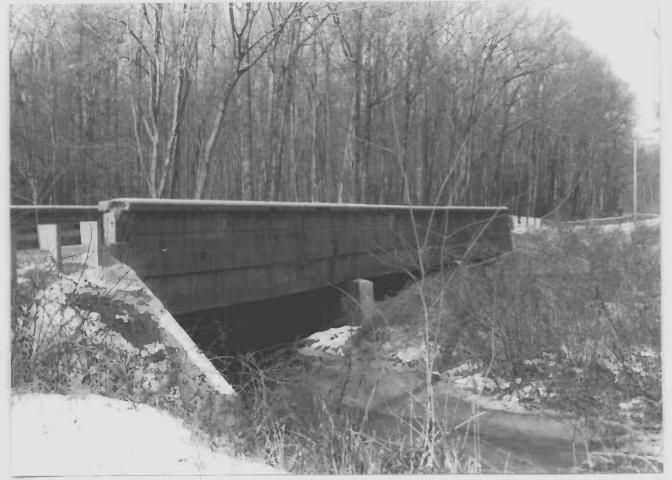
CH-383
CHARLES COUNTY, MD.
TIM BATCHER
8 FEB 1995
MARYLAND SHPO SHA
BRIDGE NO. 8028 OVER MATTAWOMEN CREEK
VIEW LOOKING SOUTH

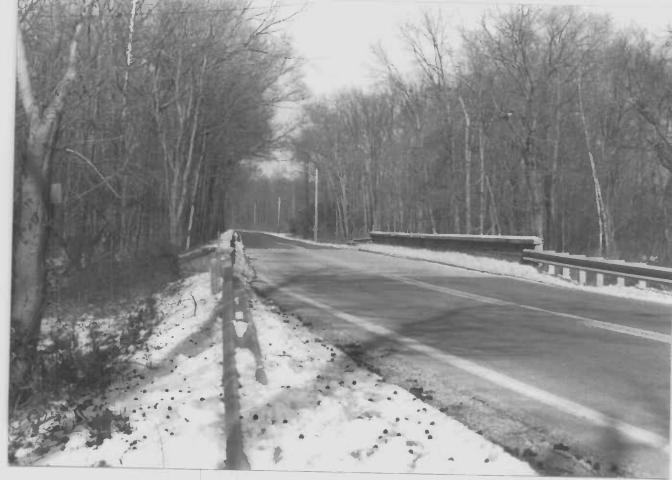
BRIDGE HO. 8028 OVER MATTAWOMEN CR.
VIEW LOOKING WEST ALONG RT 227

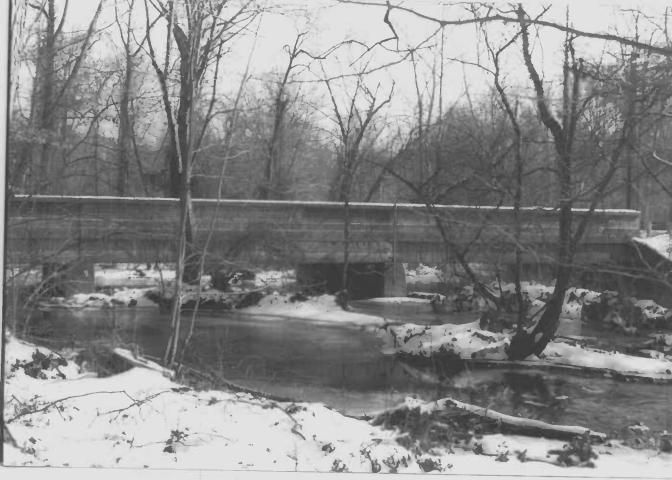
4/4

CH-383
CHARLES COUNTY, MD.
TIM BATCHER
8 FEB 1995
MARYLAND SUPO S HA
BRIDGE HO. 8028 OVER MATTAWOMEN CREEK
VIEW LOOKING HORTH
